## SUMMARY REPORT

**Client:** John Q. Smith  
**Inspection Address:** 123 Sample Street, Reno, NV 89500  
**Inspection Date:** 2/8/2011 Start: 9:00 am  
**Inspected by:** John Doe

## **CONFIDENTIAL INSPECTION REPORT**

123 Sample Street, Reno, NV 89500

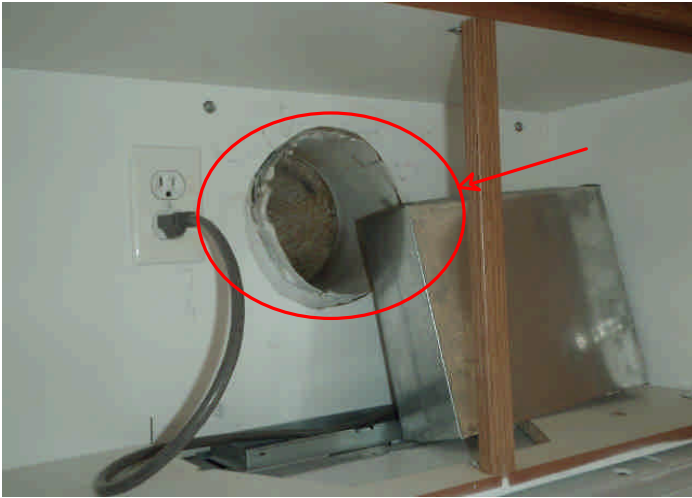
- The vent pipe for the kitchen exhaust is disjointed or not properly connected over the microwave and should be repaired.

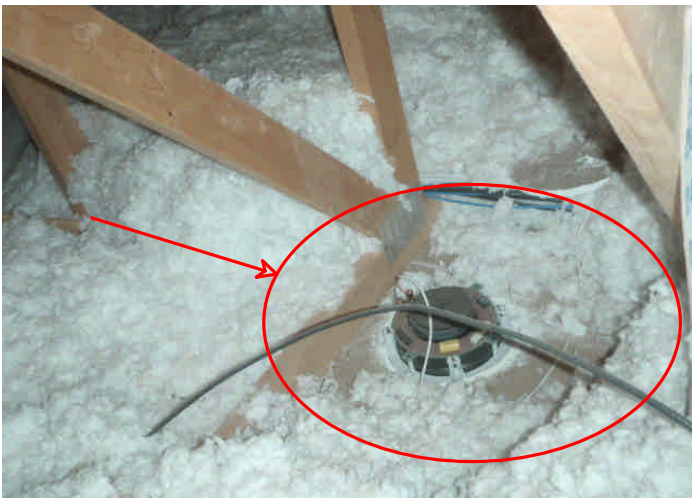
- Some attic insulation has been moved, disturbed or is out of place at speaker installation over the living room and should be reset for efficiency.

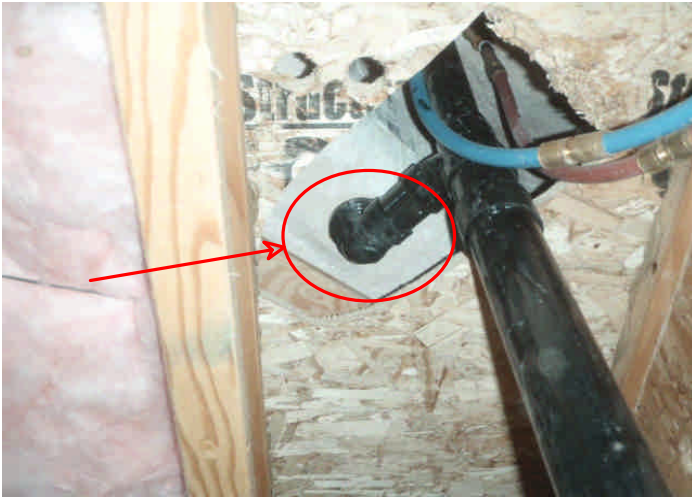
- There is a tub drain leak in the crawlspace, below the downstairs hall bathroom, which should be repaired.

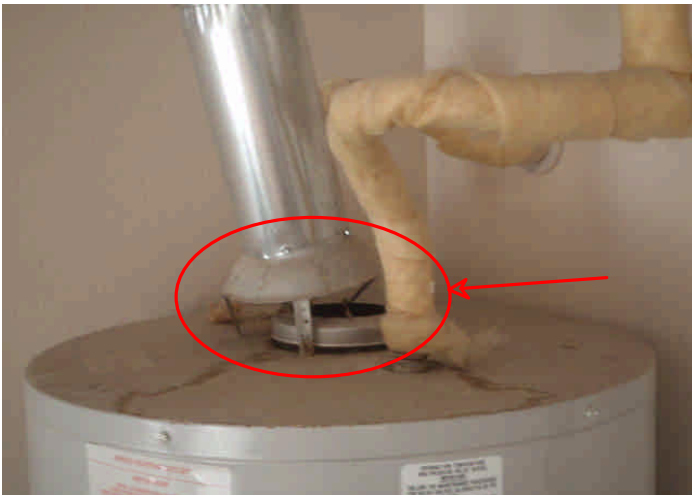
- The draft hood and vent at the top of water heater need to be aligned and secured to top of heater.

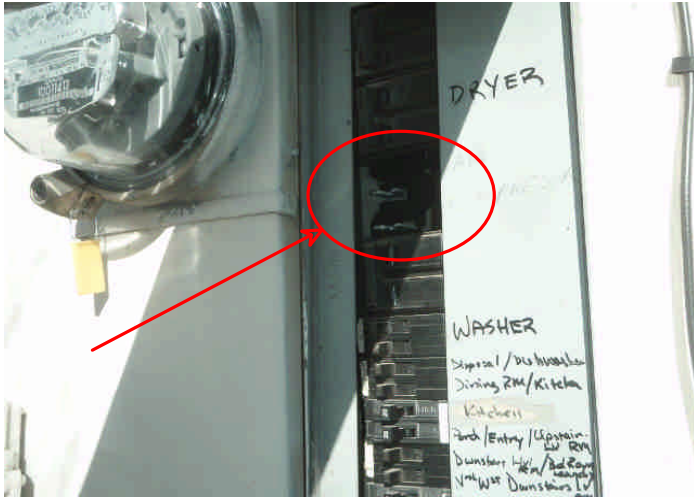
- There are voids or open knockouts in the interior cover of the main electrical service panel that should be covered.

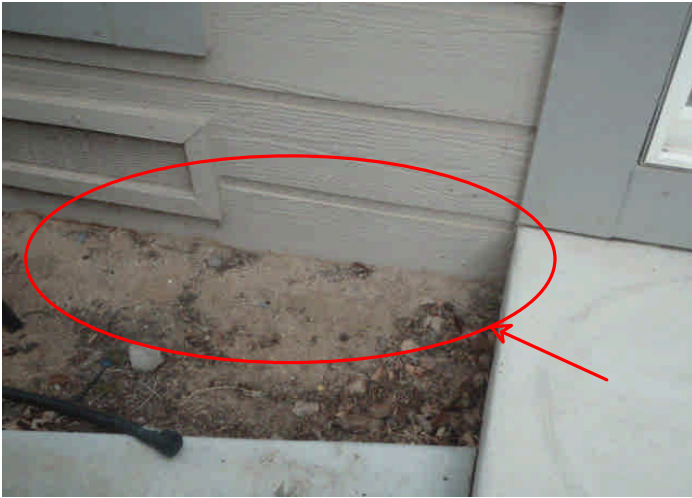
- Soils and/or landscape materials in contact with the bottom of the siding at the rear door to the exterior should be pulled away to prevent moisture damage.

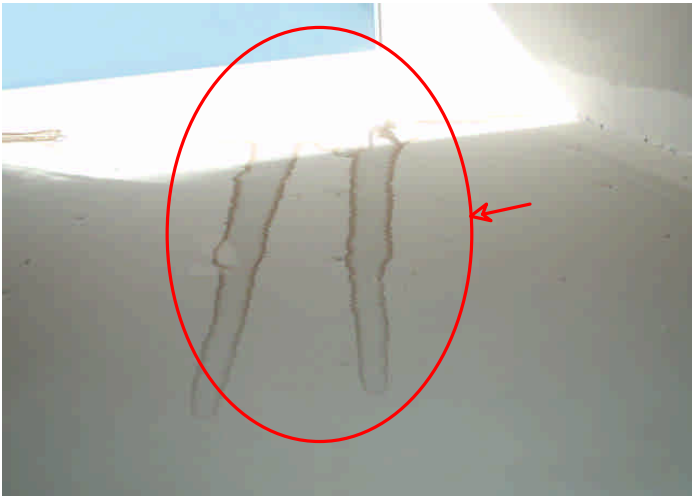
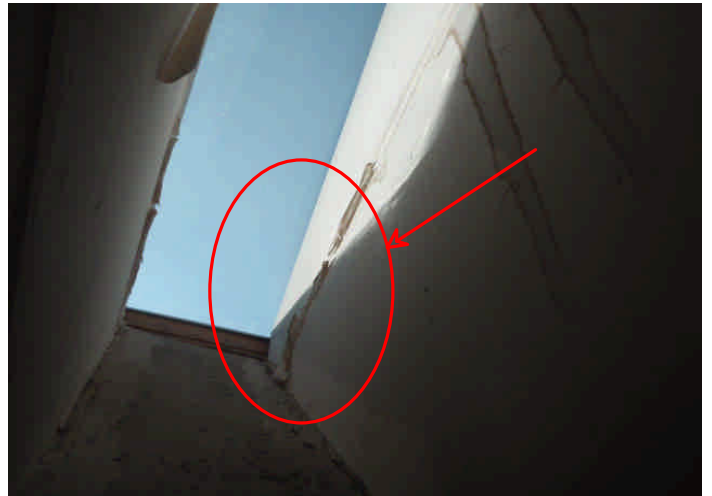
- There are stains in the interior opening of in the kitchen skylight due to prior leaks that should be further investigated and repaired by a licensed roofing contractor.

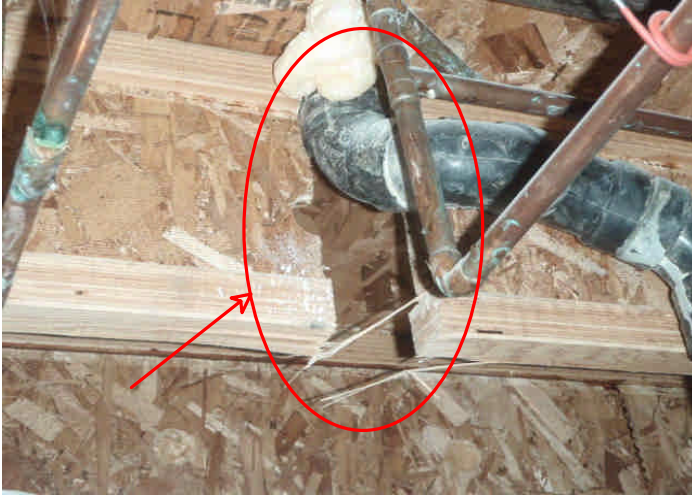
- There is an improperly modified TJI type engineered joist under the master bathroom in the crawlspace. This joist should be properly supported by a licensed contractor.

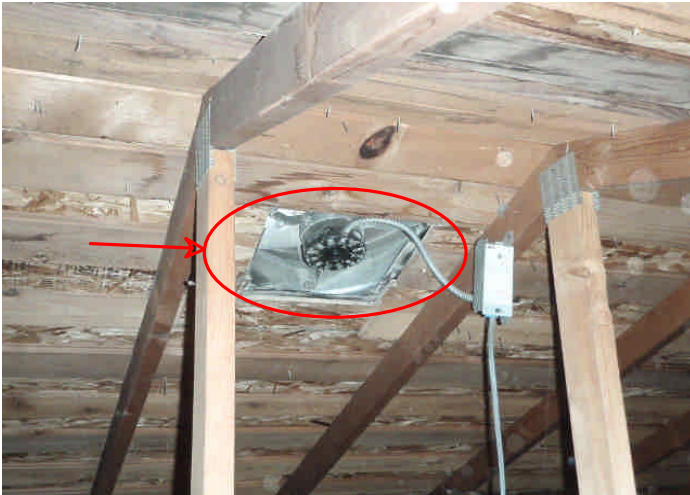
Conditions of the accessible attic space indicate that the attic ventilation is adequate for current conditions. There is a functional thermostatically controlled ventilation fan in the attic.

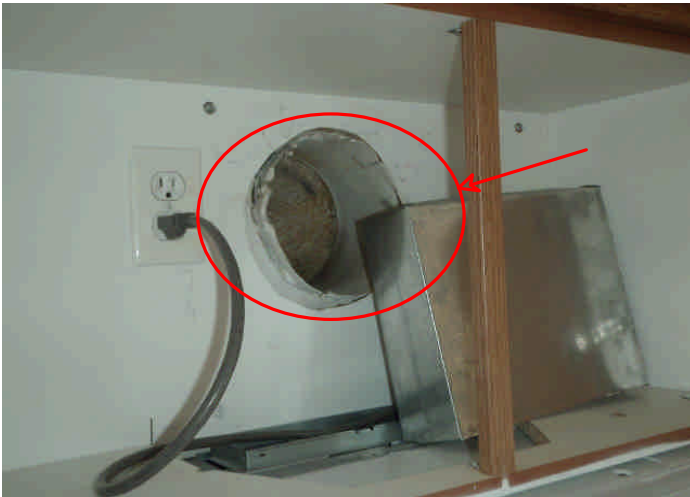
The vent pipe for the kitchen exhaust is disjointed or not properly connected over the microwave and should be repaired.

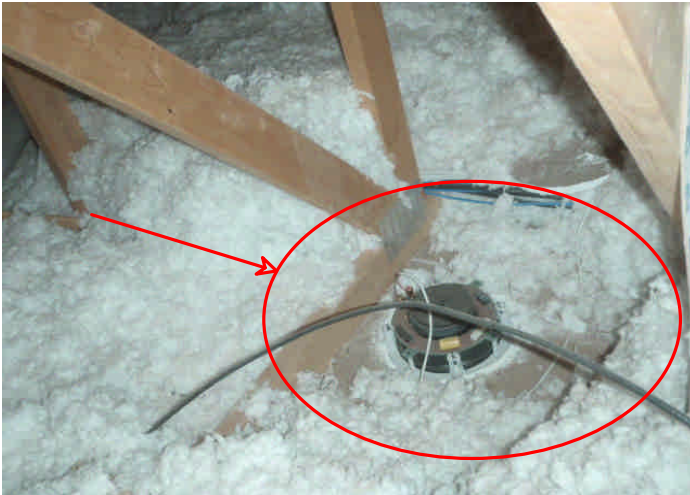
Some attic insulation has been moved, disturbed or is out of place at speaker installation over the living room and should be reset for efficiency.

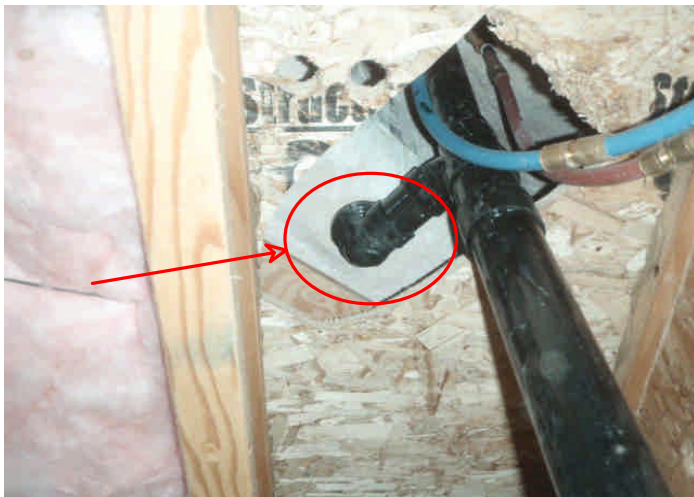
There is a tub drain leak in the crawlspace, below the downstairs hall bathroom, which should be repaired.

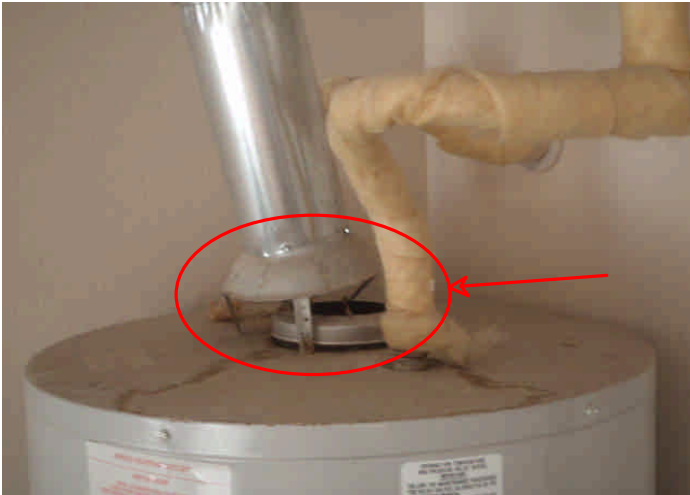
The draft hood and vent at the top of water heater need to be aligned and secured to top of heater.

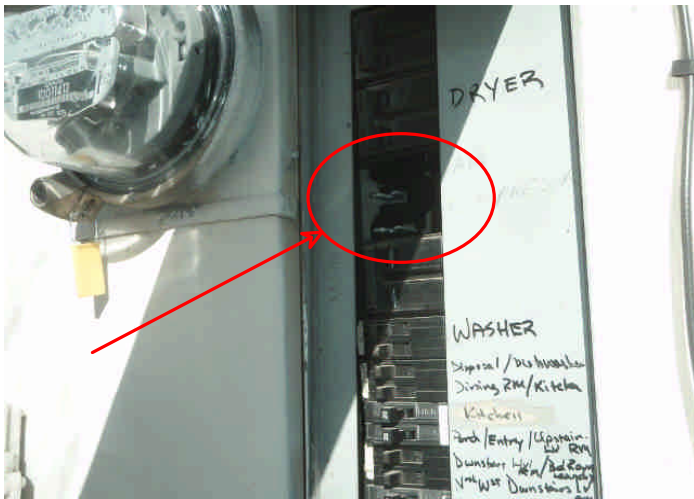
There are voids or open knockouts in the interior cover of the main electrical service panel that should be covered.

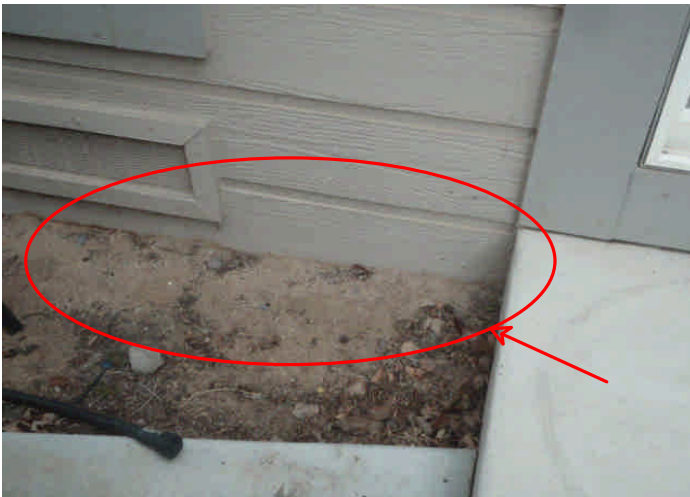
Soils and/or landscape materials in contact with the bottom of the siding at the rear door to the exterior should be pulled away to prevent moisture damage.

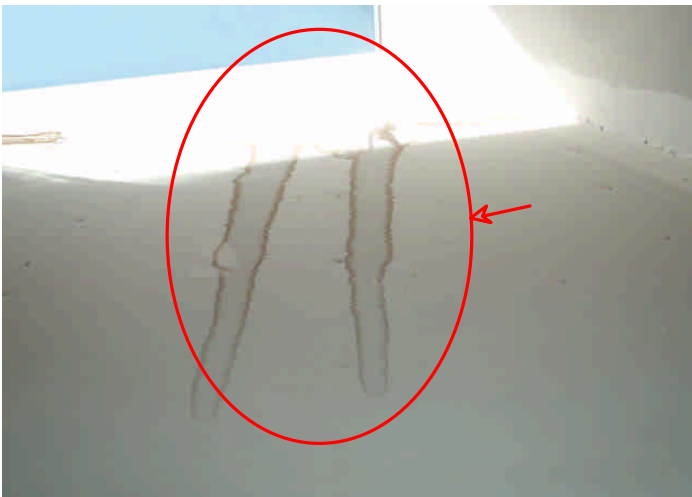
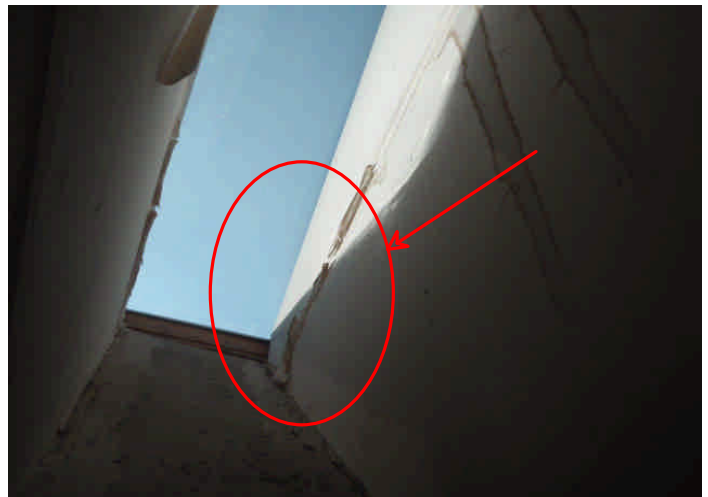
There are stains in the interior opening of in the kitchen skylight due to prior leaks that should be further investigated and repaired by a licensed roofing contractor.

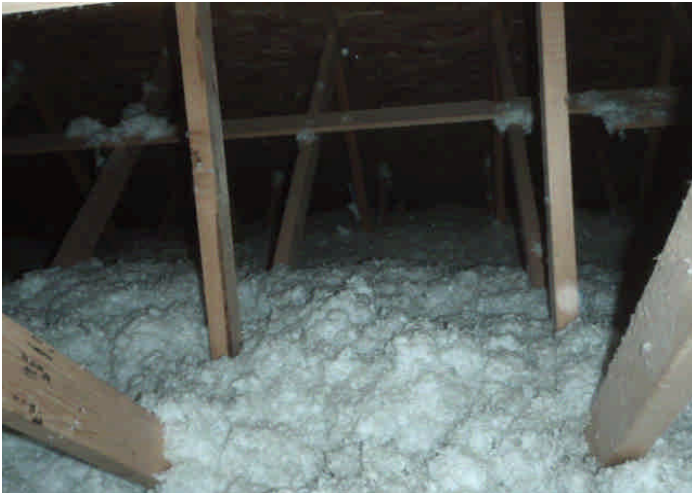
Insulation, other obstructions and/or limited head height limited access to the attic, and the area was not fully inspected. Most areas of the attic were not accessed or inspected.

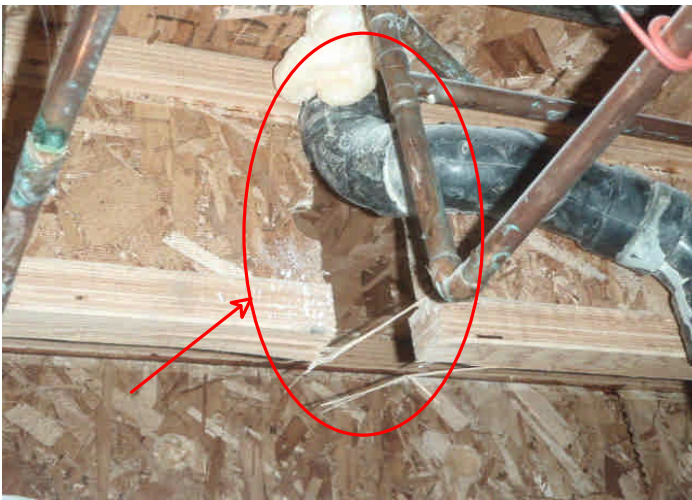
There is an improperly modified TJI type engineered joist under the master bathroom in the crawlspace. This joist should be properly supported by a licensed contractor.
